**Inspection Report for
Apple Valley Heights CWD
Apple Valley, CA**

**20KG Steel On-Grade
West Tank**

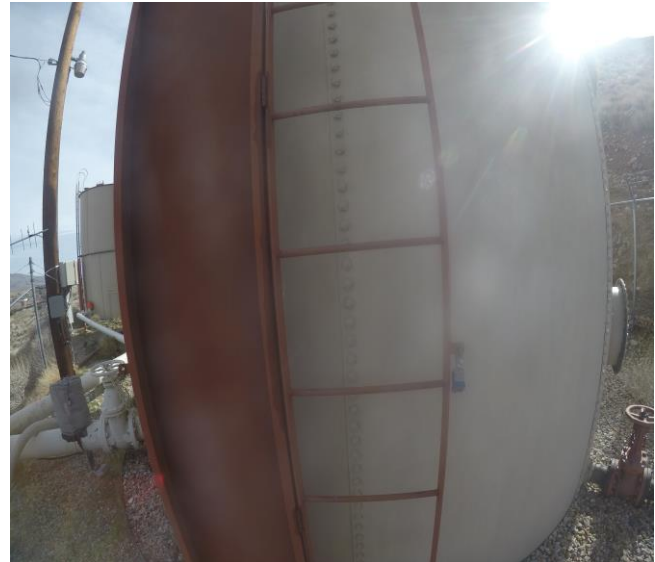
Summary: The ladder was found secure, OSHA approved and in good condition with minor de-lamination, oxidation, moderate chalking and 0.1% uniform surface corrosion noted.

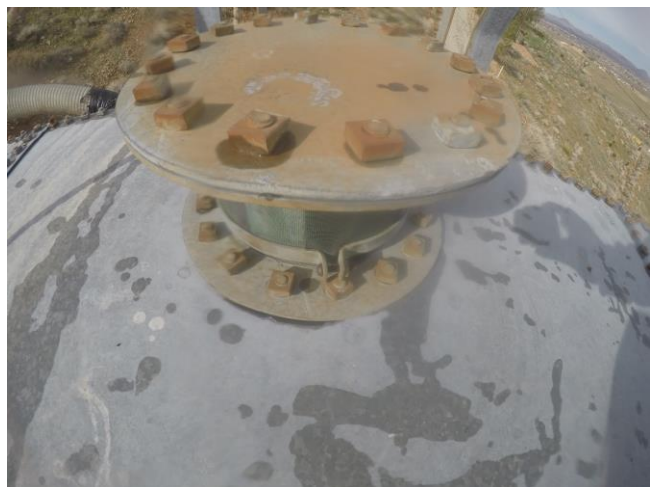
Summary: The vent was found in good condition with minor oxidation and 0.01% uniform surface corrosion noted.

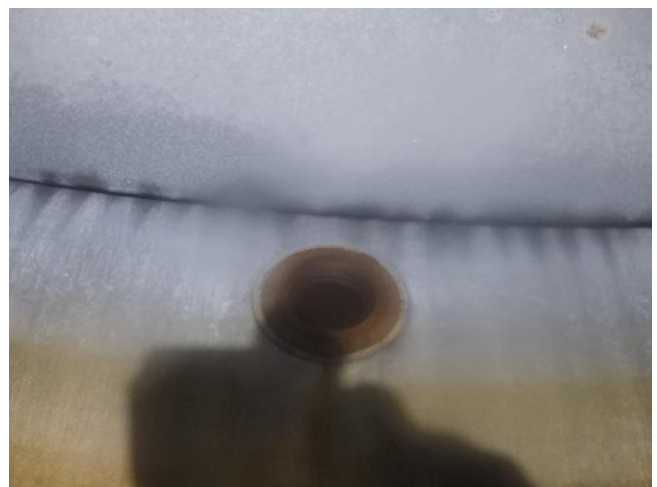
Wall Panel Condition

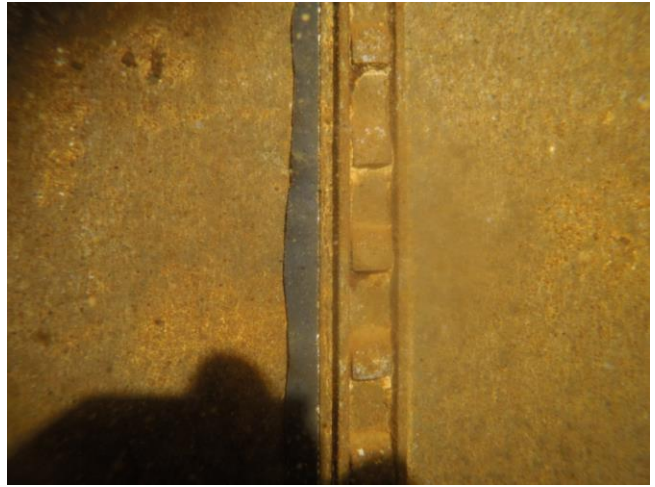
Summary: The wall was found in good condition with heavy staining, 1/32 inch deep pitting, 0.01% rust noduling and 0.3% uniform surface corrosion noted.

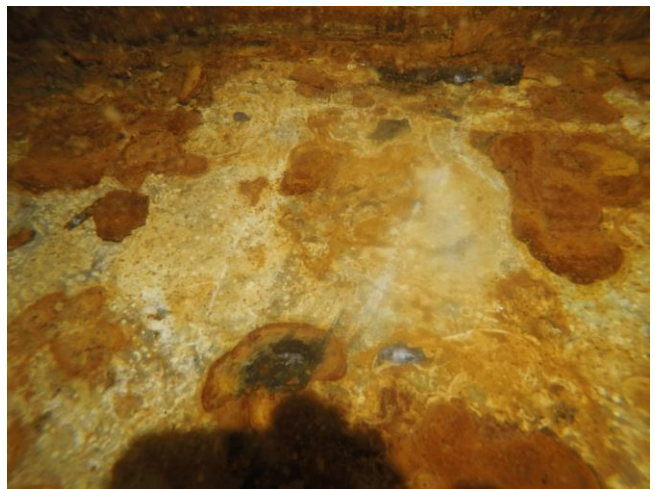
Summary: The floor was found in poor condition with heavy staining, 1/32 inch deep pitting, 33% rust noduling and greater than 50% uniform surface corrosion noted.

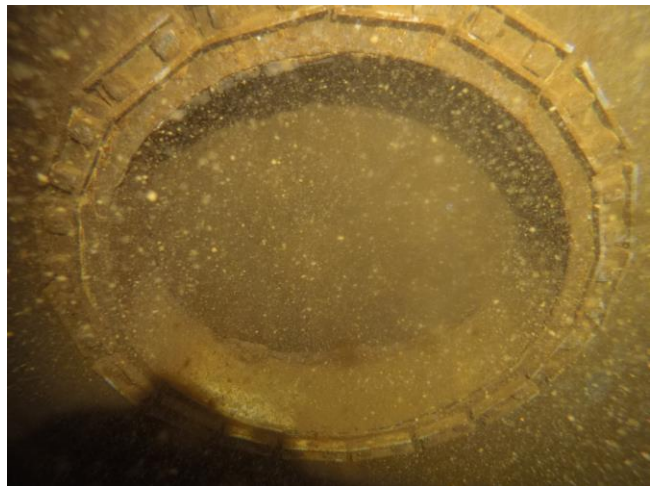
Inlet and Outlet Condition

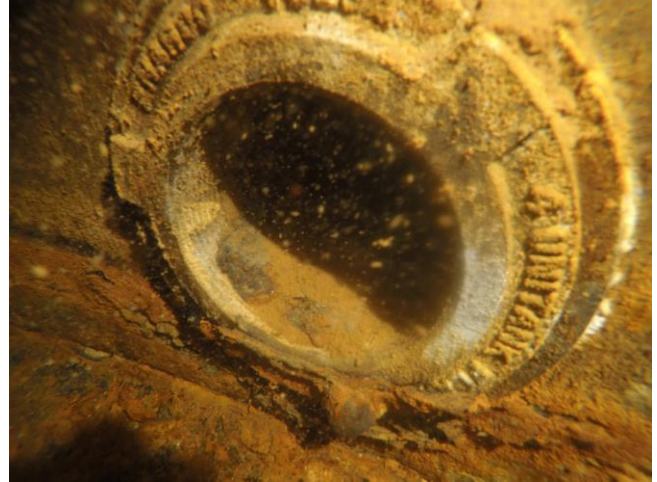
Summary: The common inlet/outlet was found in good condition with moderate to heavy staining, 0.01% rust noduling and 1% uniform surface corrosion noted.

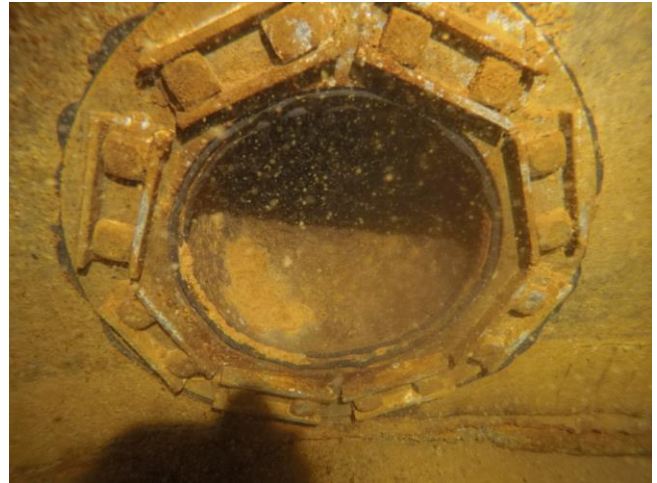
Summary: The drain was found in good condition with heavy staining, 0.3% rust noduling and 3% uniform surface corrosion noted.

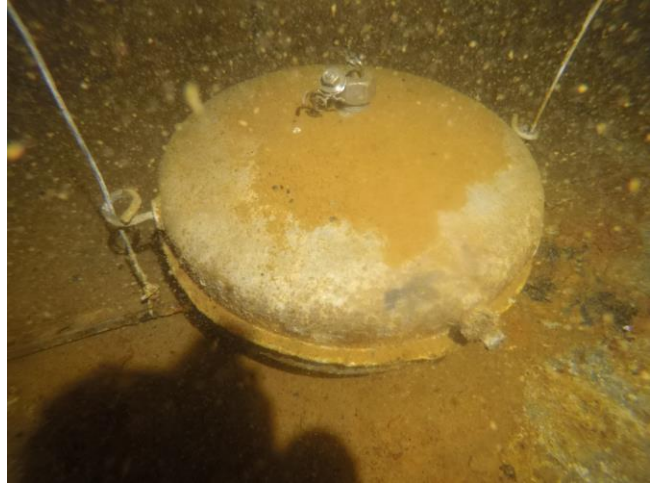
Support Column Condition

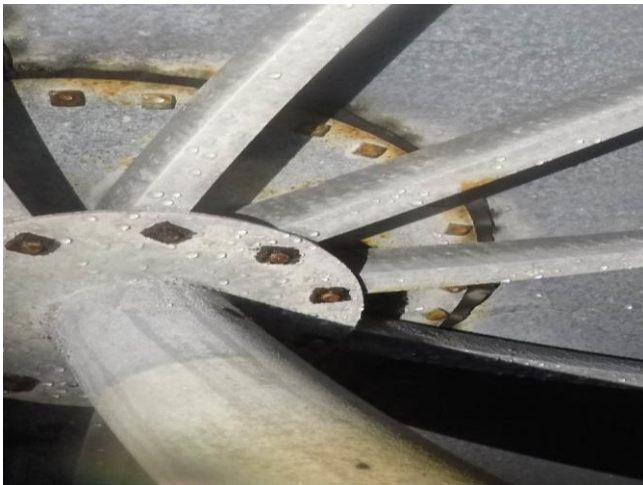
Summary: The support column was found secure and in good condition with minor oxidation and moderate staining noted.
