**Inspection Report for
Apple Valley Heights CWD
Apple Valley, CA**

**20MG Steel On-Grade
East Tank**

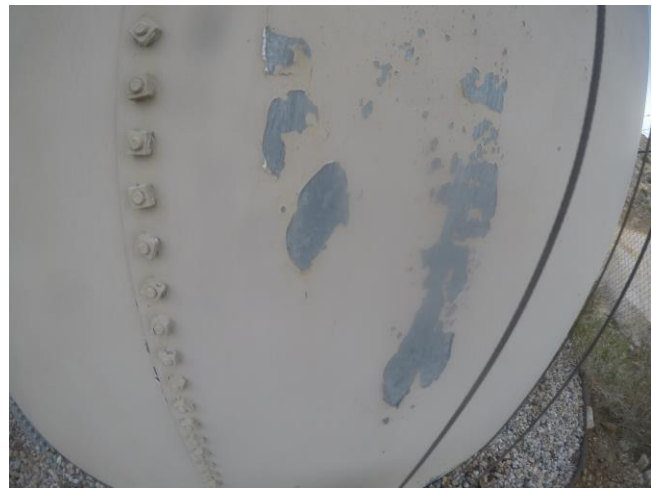
Overflow Structure Condition

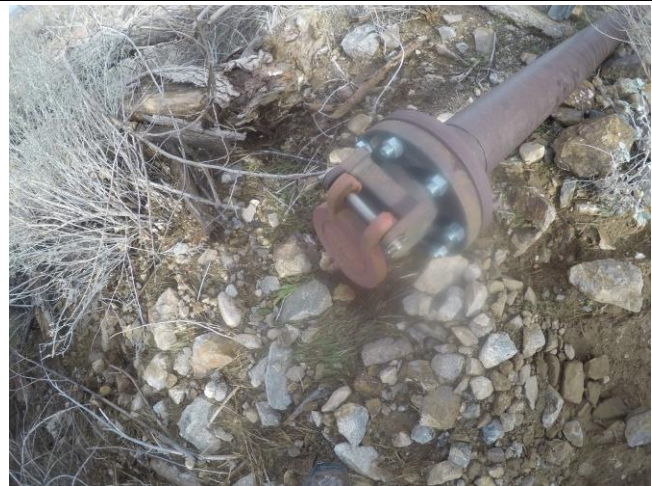
Summary: The overflow was found in poor condition with heavy oxidation, 0.3% erosion corrosion and 16% uniform surface corrosion noted. There are also holes in the pipe.

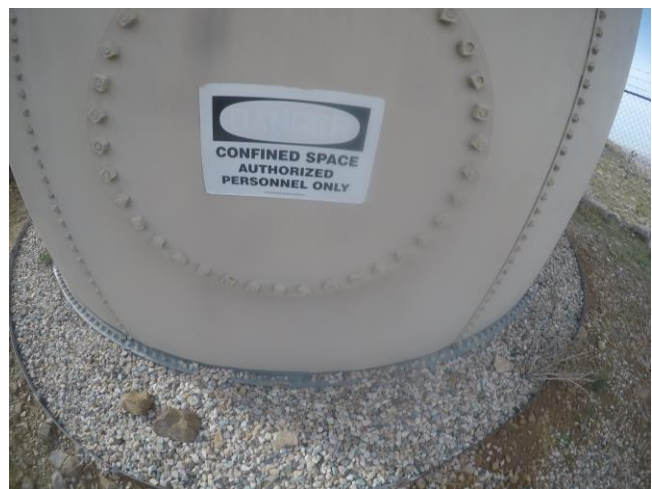
Water Level Indicator Condition

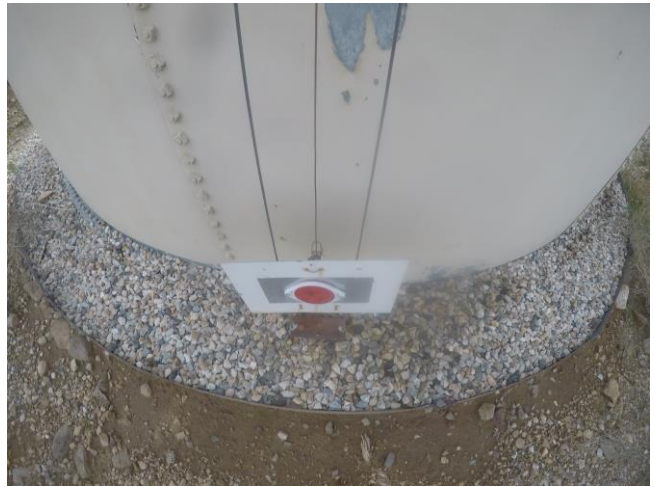
Access Ladder Condition

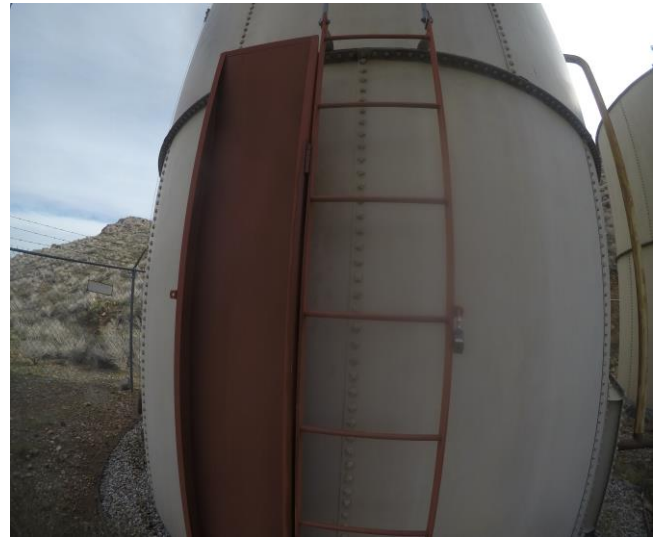
Summary: The ladder was found secure, OSHA approved and in good condition with minor oxidation, moderate chalking and 0.03% uniform surface corrosion noted.

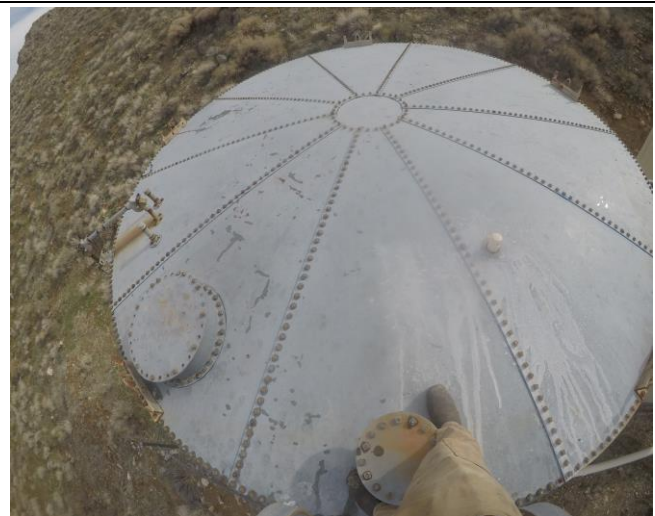
Access Hatch Condition

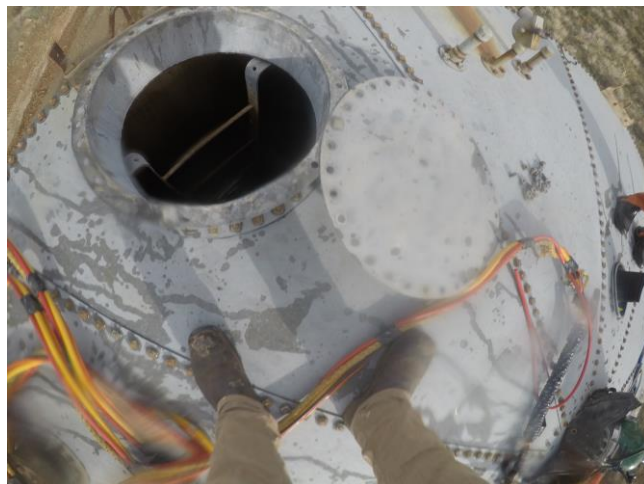
Summary: The hatch was found bolted shut with no gasket present and in good condition.

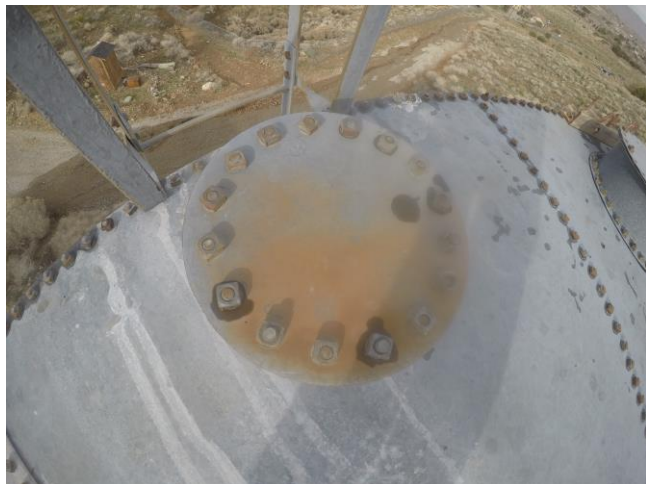
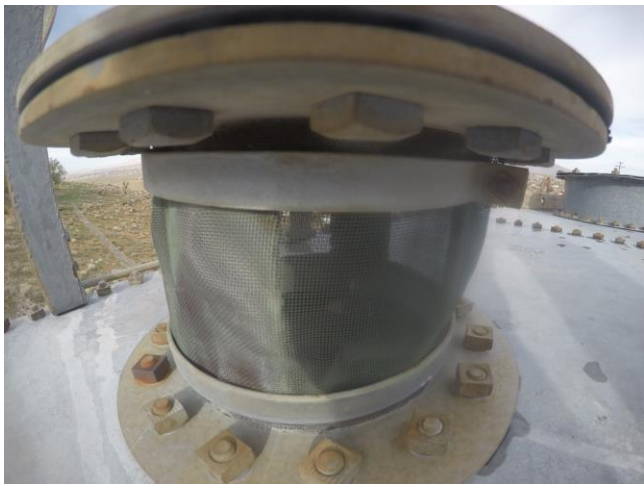
Summary: The vent was found in good condition with minor corrosive staining and 0.1% uniform surface corrosion noted.

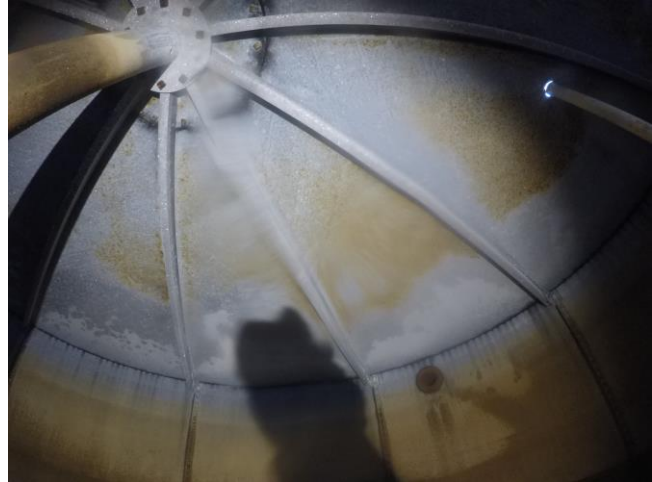
Summary: The interior roof was found in good condition with minor oxidation and 0.01% uniform surface corrosion noted.

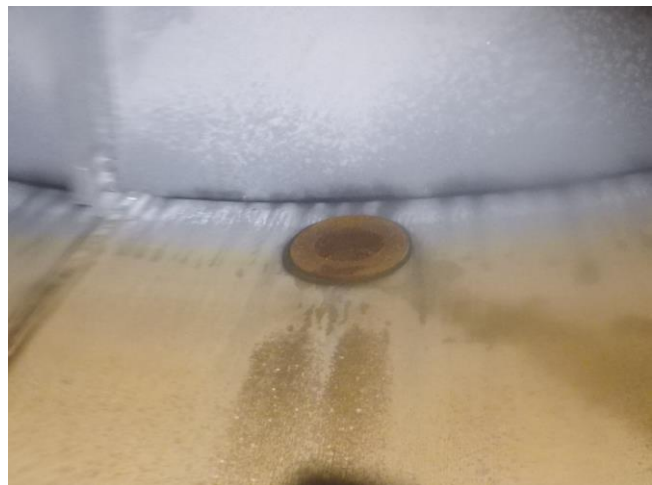
Wall Panel Condition

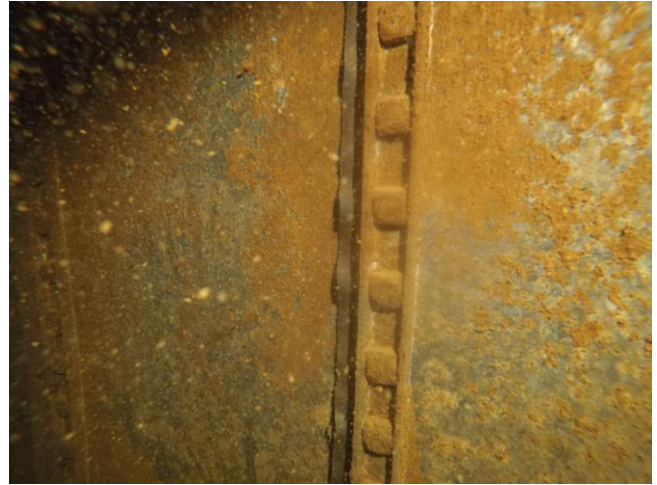
Summary: The interior wall was found in good condition with minor to moderate corrosive staining, heavy sediment staining and 0.1% uniform surface corrosion & rust noduling noted.

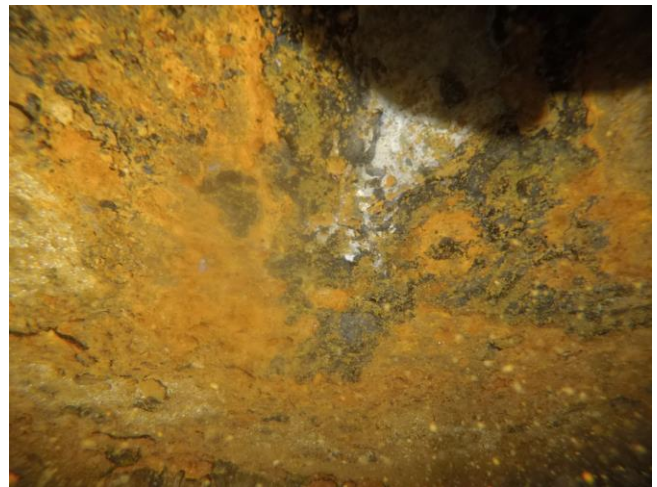
Summary: The floor was found in poor condition with heavy sediment & corrosive staining, 1/32 inch deep pitting, 50% rust noduling and greater than 50% uniform surface corrosion noted.

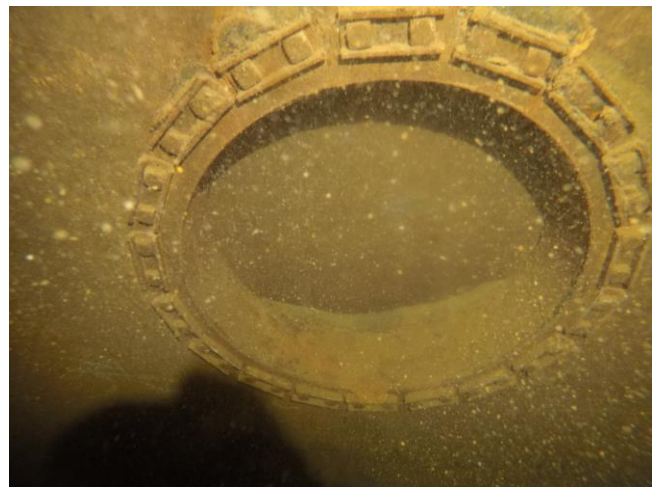
Inlet and Outlet Condition

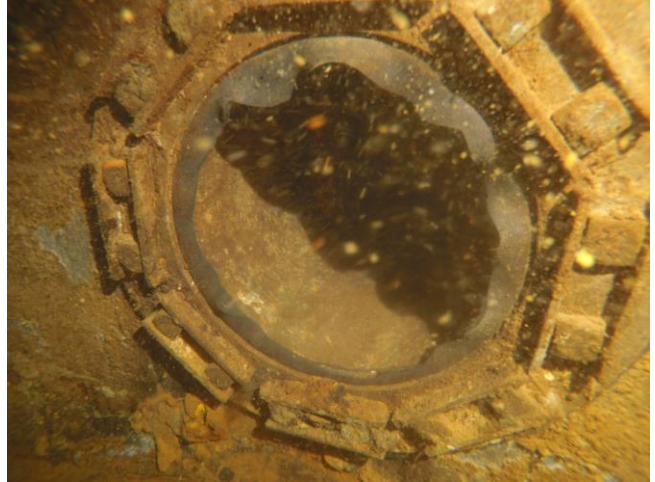
Summary: The common inlet/outlet was found in good condition with heavy corrosive & sediment staining, 1/32 inch deep pitting, 0.1% rust noduling and 0.3% uniform surface corrosion noted.

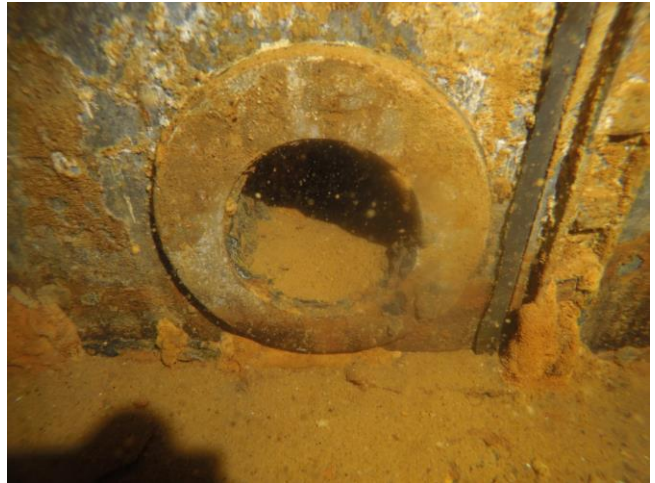
Summary: The drain was found in good condition with heavy sediment & corrosive staining, 0.01% rust noduling and 0.1% uniform surface corrosion noted.

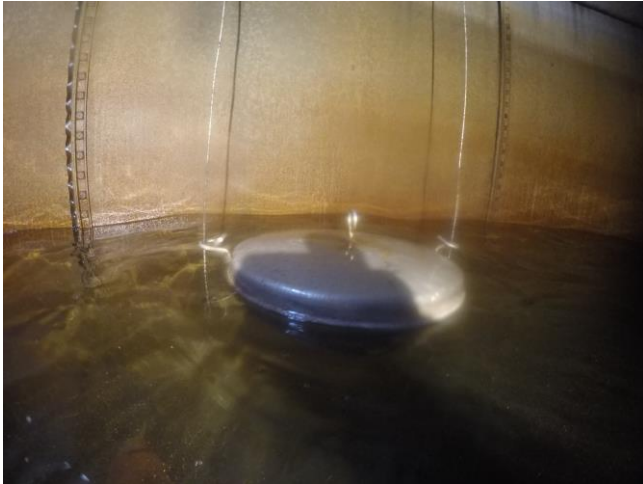
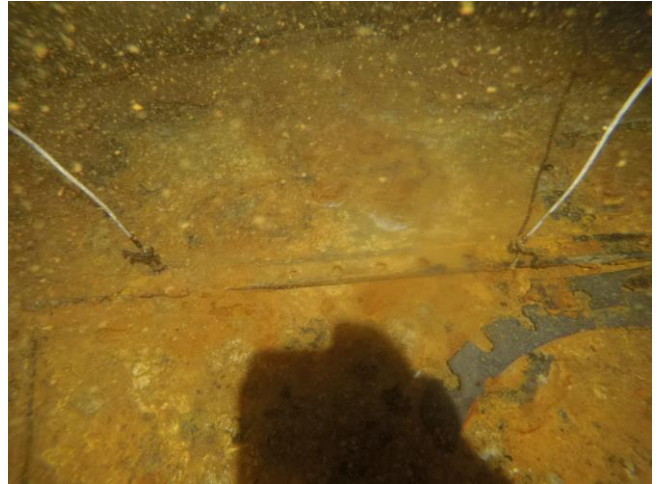
Support Column Condition

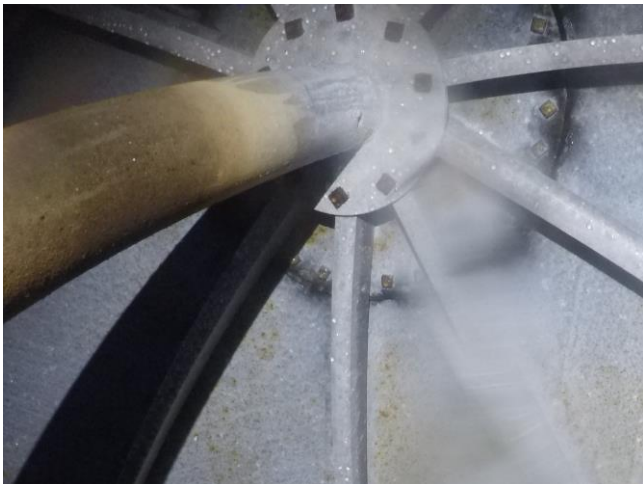
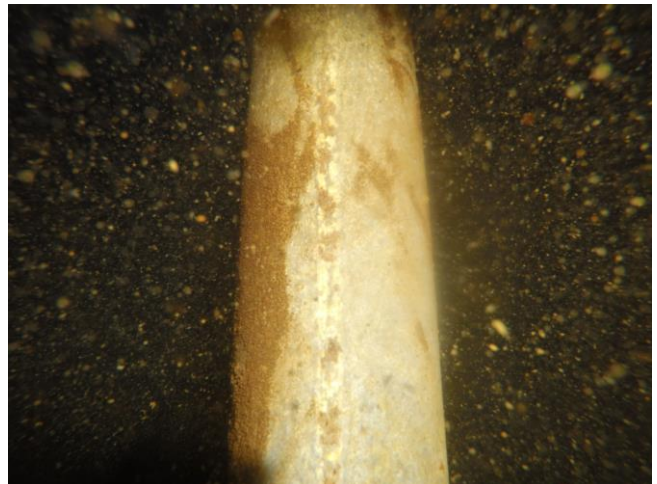
Summary: The support column was found secure and in good condition with minor corrosive staining, heavy sediment staining and 0.1% uniform surface corrosion noted.
