**Inspection Report for  
Apple Valley Heights CWD  
Apple Valley, CA**

**20KG Steel On-Grade  
West Tank**

**Date Completed: January 9, 2023**

## Exterior Inspection Report

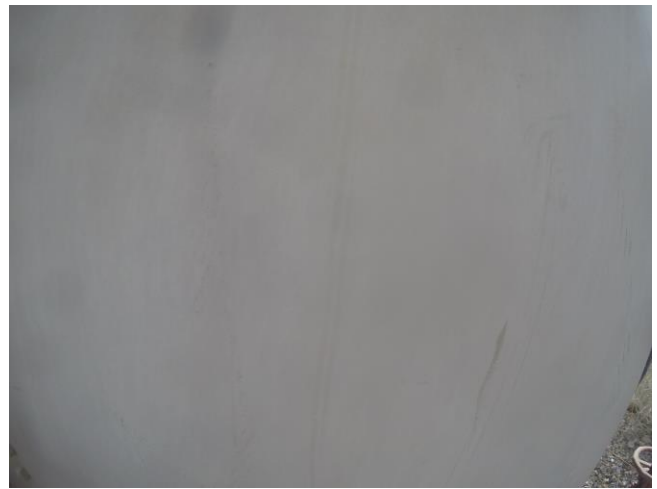
### Wall Panel Condition

Summary: The wall was found in good condition with minor oxidation, moderate sags & runs in the coating and heavy chalking noted.

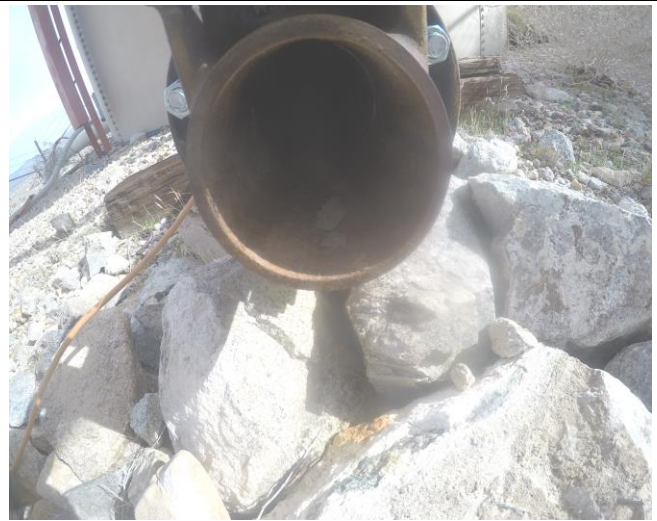
### Overflow Structure Condition

Summary: The overflow was found in fair condition with moderate chalking, heavy de-lamination, oxidation, 3% intergranular corrosion and 10% uniform surface corrosion noted.

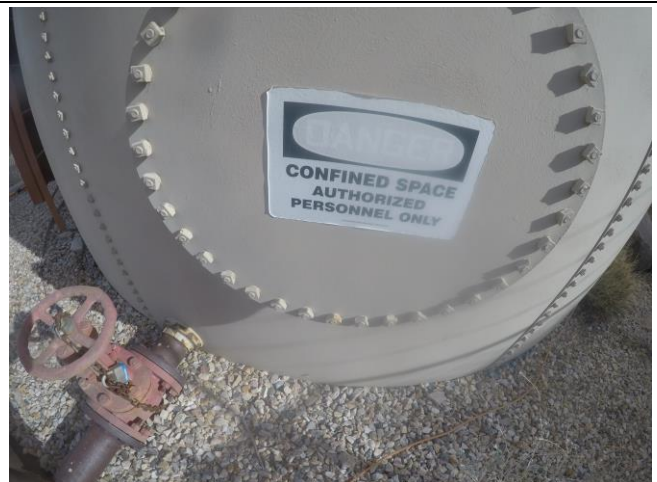
### Manway Condition

Summary: The manway was found secure and in good condition with minor oxidation and heavy chalking noted.

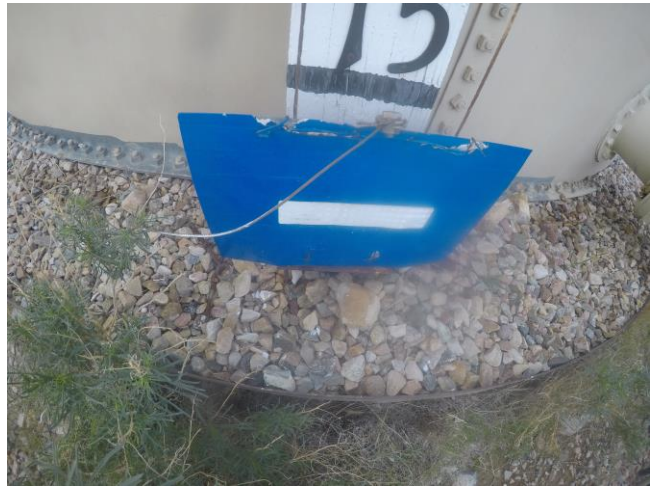
### Water Level Indicator Condition

Summary: The water level indicator was found in poor condition with 3% uniform surface corrosion noted and the cable and guidelines unattached.

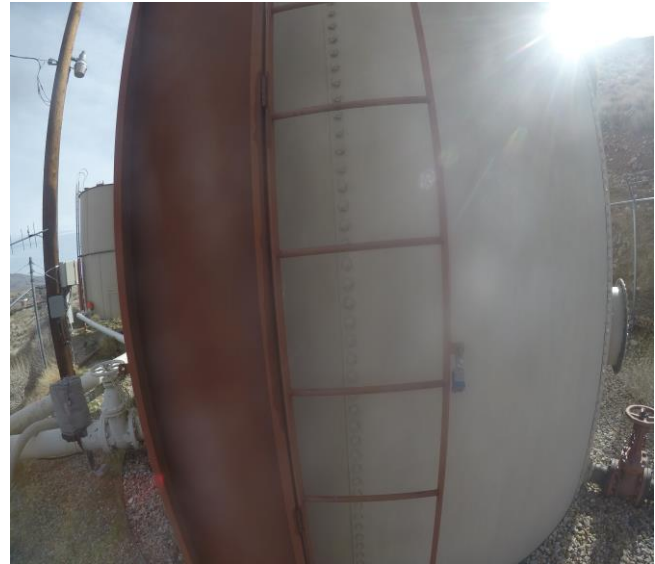
### Access Ladder Condition

Summary: The ladder was found secure, OSHA approved and in good condition with minor de-lamination, oxidation, moderate chalking and 0.1% uniform surface corrosion noted.

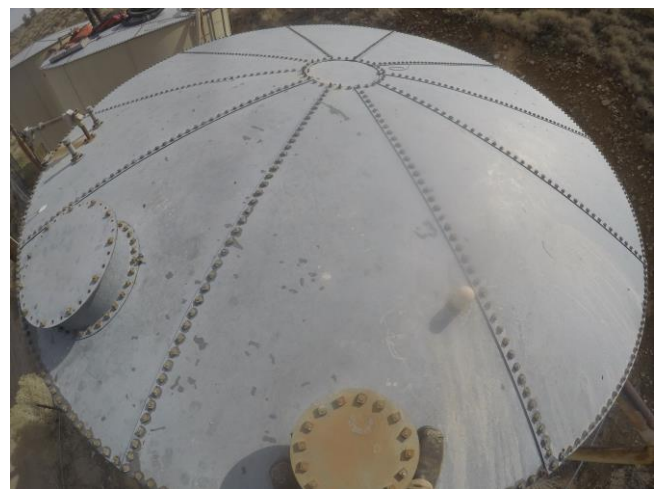
### Roof Condition

Summary: The uncoated roof was found in good condition.

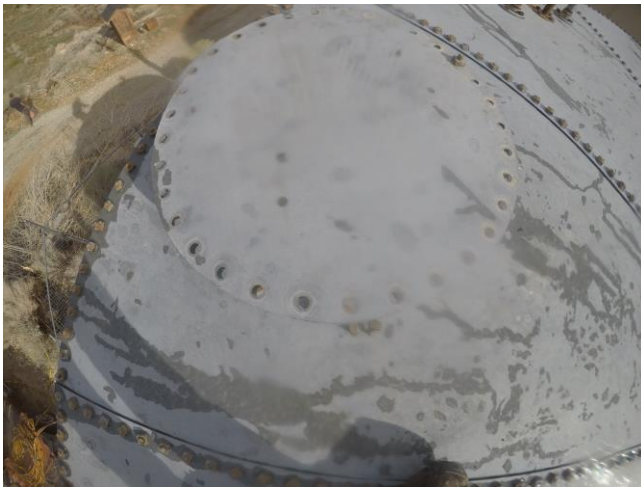
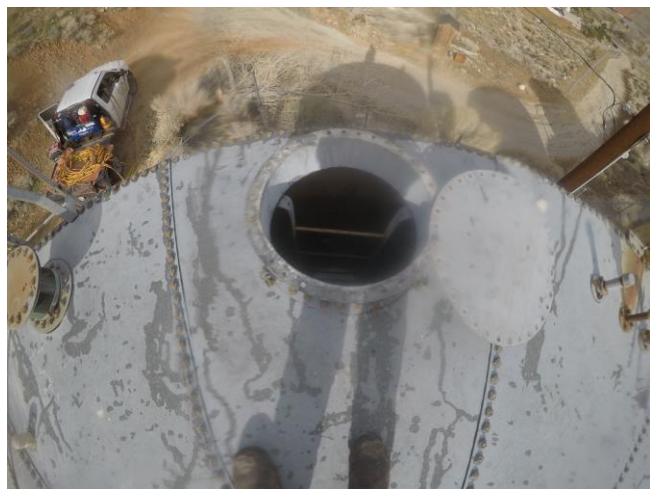
### Access Hatch Condition

Summary: The uncoated hatch was found bolted down with no gasket present and in good condition.

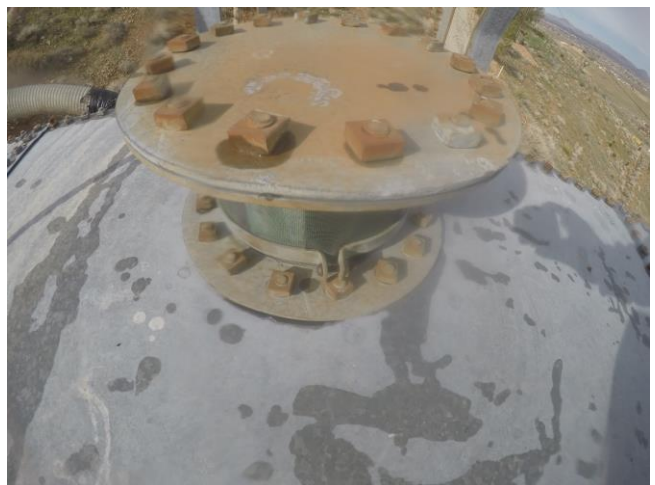
### Vent Condition

Summary: The vent was found in good condition with minor oxidation and 0.01% uniform surface corrosion noted.

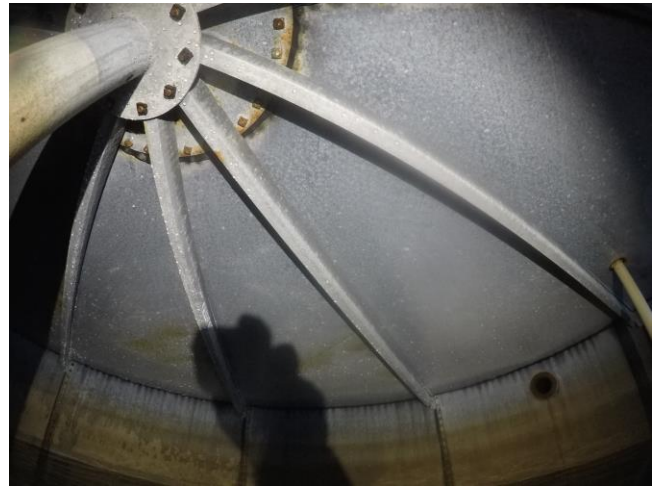
### Roof Condition

Summary: The interior roof was found in good condition with minor oxidation and 0.01% intergranular corrosion noted.

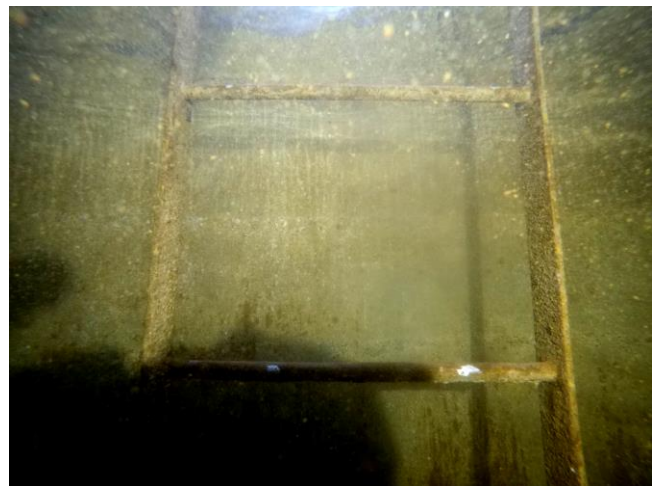
### Ladder Condition

Summary: The ladder was found secure and in good condition with minor staining and 0.3% uniform surface corrosion noted.

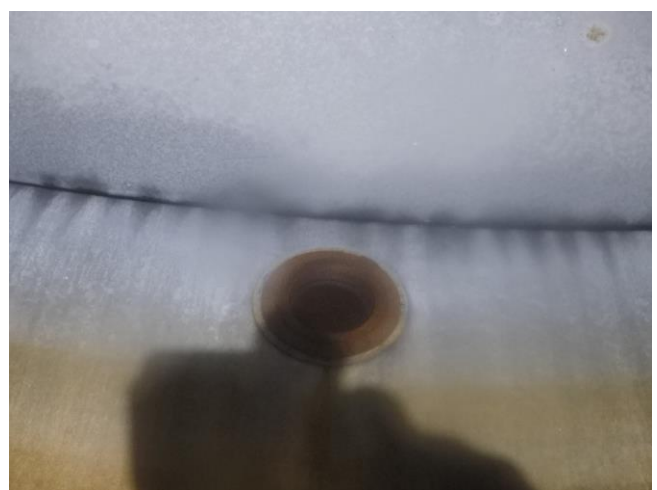
### Overflow Condition

Summary: The overflow was found in good condition with minor corrosive staining, minor to moderate oxidation and 0.01% uniform surface corrosion noted.

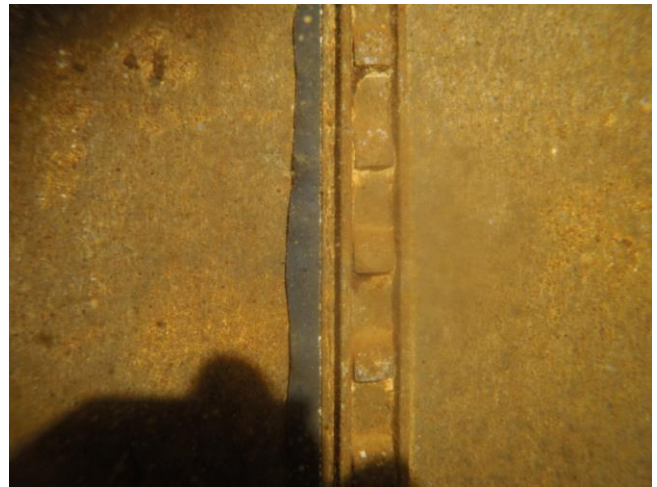
### Wall Panel Condition

Summary: The wall was found in good condition with heavy staining, 1/32 inch deep pitting, 0.01% rust noduling and 0.3% uniform surface corrosion noted.

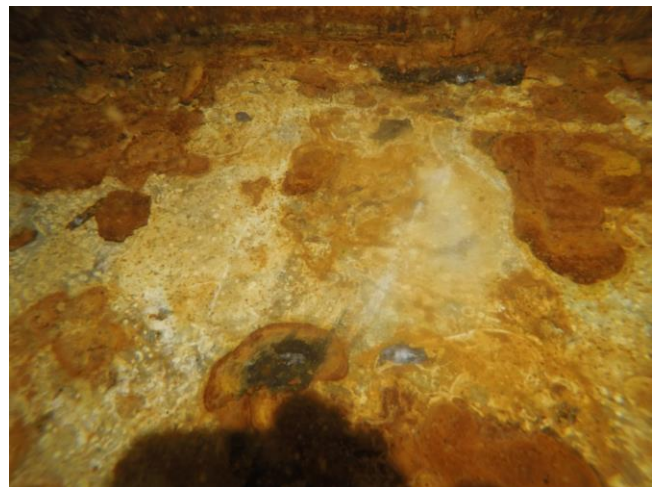
### Floor Condition

Summary: The floor was found in poor condition with heavy staining, 1/32 inch deep pitting, 33% rust noduling and greater than 50% uniform surface corrosion noted.

1. Schedule a blast and recoat of the interior or replace the floor as soon as budgets will allow. If, within 3 years, the recoating or replacing has not been completed, schedule a follow-up clean and inspect as recommended by the AWWA.

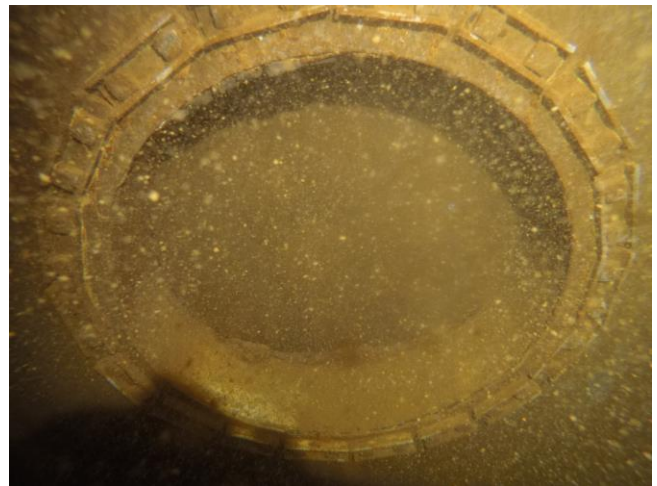
### Manway Condition

Summary: The manway was found in good to fair condition with heavy staining, 0.01% rust noduling and 16% uniform surface corrosion noted.

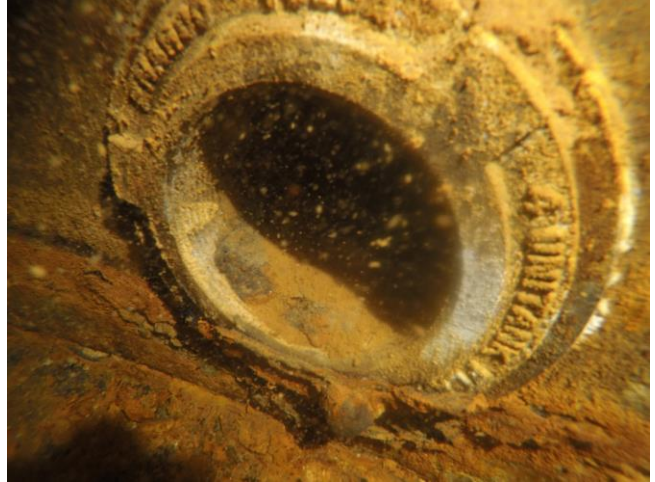
### Inlet and Outlet Condition

Summary: The common inlet/outlet was found in good condition with moderate to heavy staining, 0.01% rust noduling and 1% uniform surface corrosion noted.

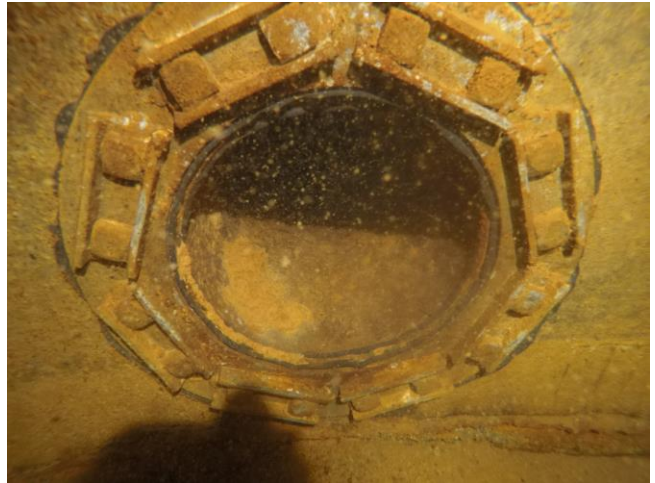
### Drain Condition

Summary: The drain was found in good condition with heavy staining, 0.3% rust noduling and 3% uniform surface corrosion noted.

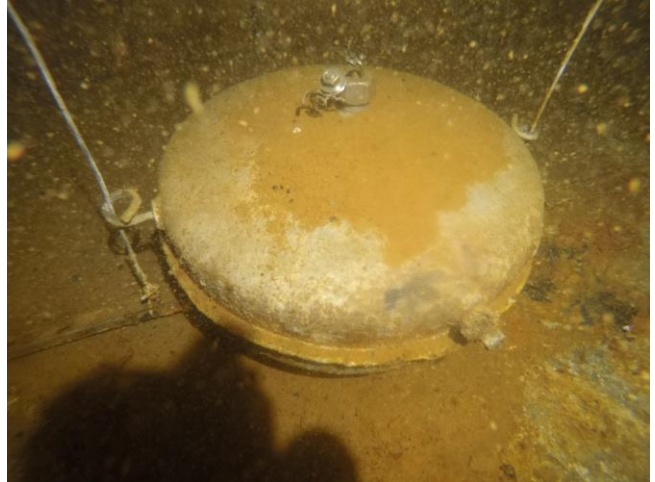
### Float Condition

Summary: The float was found in poor condition with the cable and guidelines unattached.

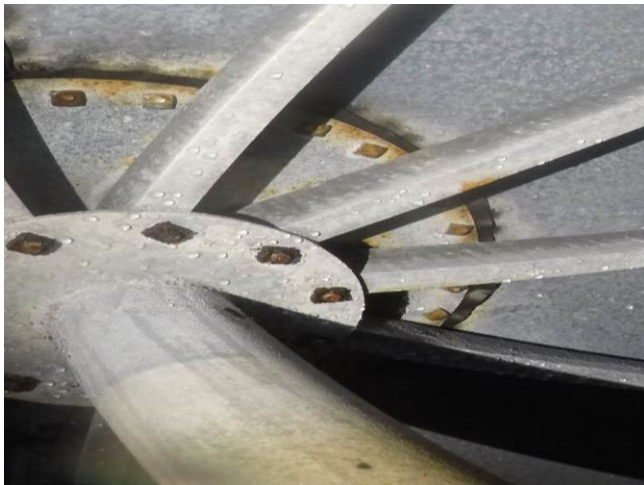
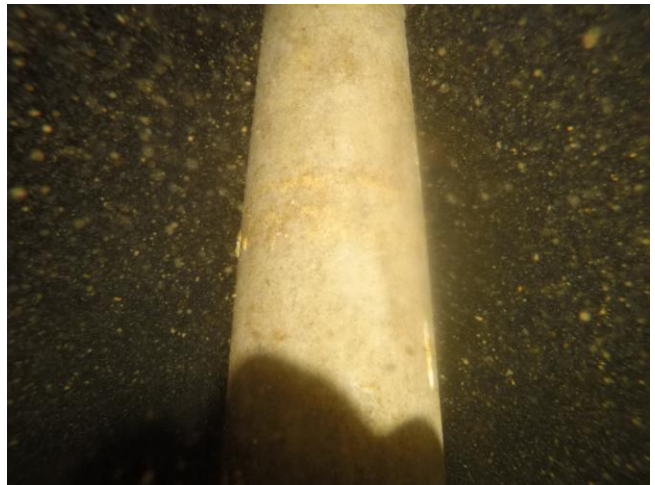
### Support Column Condition

Summary: The support column was found secure and in good condition with minor oxidation and moderate staining noted.
